**UNITED STATES DISTRICT COURT  
FOR THE CENTRAL DISTRICT OF CALIFORNIA  
SOUTHERN DIVISION – SANTA ANA**

**COMPLAINT FOR DAMAGES AND  
INJUNCTIVE RELIEF**

4 1. This action seeks to redress the latent defects in Fluidmaster's "NO BURST"  
5 Toilet Connectors with acetal coupling nuts ("Toilet Connector"). Fluidmaster couches itself as  
6 a world leader in toilet repair and plumbing products. During the relevant period, Fluidmaster  
7 designed, manufactured, distributed, and sold flexible Toilet Connectors. To permit water flow  
8 into the toilet tank, a Toilet Connector connects the water fixture shut-off valve to the base of the  
9 toilet using a plastic coupling nut. These plastic coupling nuts are uniformly defective in their  
10 design and labeling. As a result, the Toilet Connector poses a substantial risk of failure by  
11 permitting the unrestricted flow of water into the home causing damage to property.

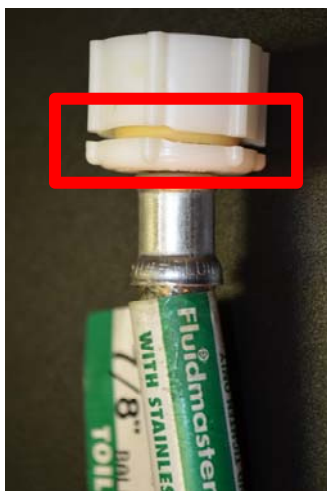
PLAINTIFF RENSEL'S  
FAILED CONNECTOR

23 9. Plaintiff, Steven Rensel, is a resident of the State of Arizona, City of Scottsdale.  
24 On September 25, 2013, the plastic coupling nut on a Fluidmaster “NO-BURST®” toilet supply  
25 line fractured and failed causing property damage. Mr. Rensel purchased the supply line less  
26 than four years prior to its failure from an Arizona home improvement store, and he installed it  
27 himself, by hand. As depicted in the picture below, the Toilet Connector included a “10 year  
28 warranty.”

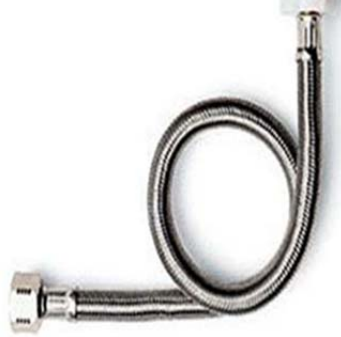
**Fluidmaster Toilet  
Connector with Plastic  
Coupling Nut**

16. Initially, when first introduced to the market, the coupling assemblies on both ends of the Toilet Connector were made of metal. The metal couplings connected to both the water shut-off valve and the toilet. These metal nuts were not susceptible to fracture.

17. Due to the cost associated with the materials for, and manufacture of, the metal nut, Fluidmaster replaced the toilet attachment end with a cheaper acetal plastic coupling nut sometime in the early 1990s. Fluidmaster's plastic design, however, is more akin to a metal design, which fails to account for the material and behavioral differences of plastic.

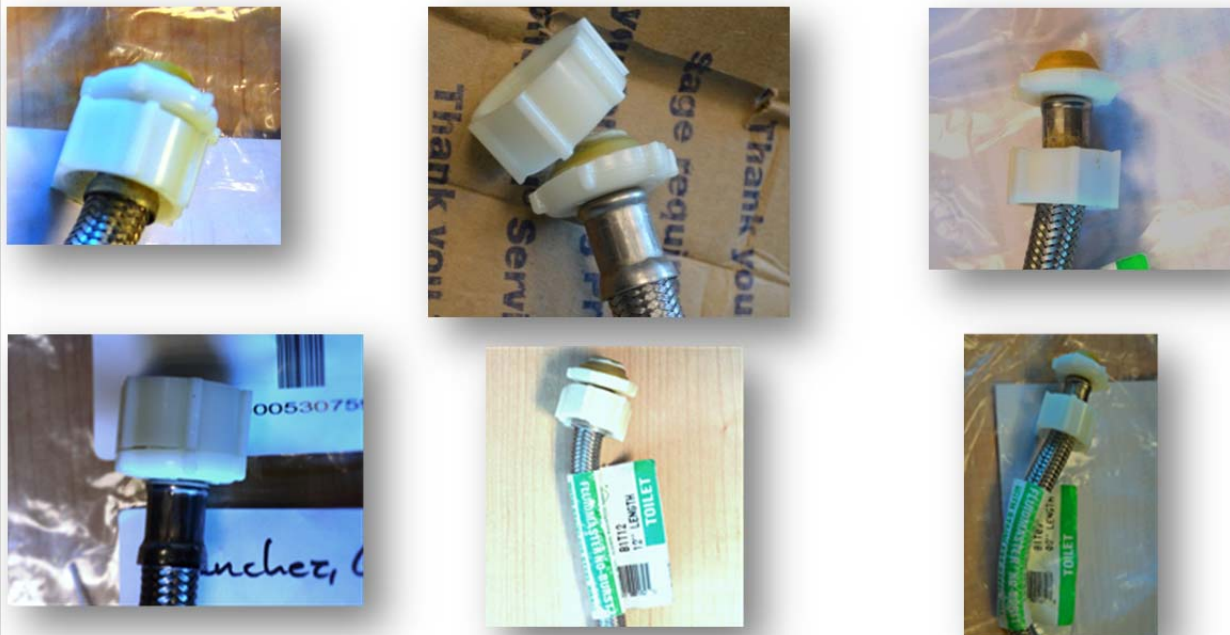
Figure 1

21. Since 2007, hundreds - *if not thousands*- more of Fluidmaster's Toilet Connectors have failed, and continue to fail, for the identical reason – circumferential fracture at the base of the plastic coupling – causing millions of dollars in damage. (*See* Figure 1).

22. These repeated, circumferential fractures are the direct result of the defective design and labeling of the Toilet Connector. The Toilet Connector's plastic coupling nut fails to adhere to the most basic design standards in the plastics industry.
